Microtrak 7000 Non-contact Laser Displacement System Measures Jet Turbine Blade Vibration

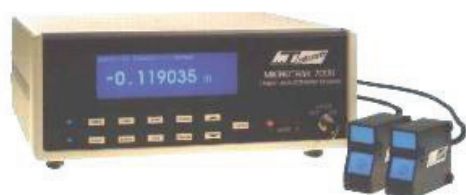
The Microtrak 7000's (see figure 3) ability to operate at a safe distance away from the hot turbine blades as well as the ability to measure through a small gap helped the customer obtain higher accuracy and more meaningful data than with previous systems. Vibration results were obtained faster and at a lower cost than with a CCD camera or a Laser Vibrometer. Additionally the feature of interchangeable laser heads allowed the customer the ability to test and analyze their wide variety of turbine blades and other engine components.

After reviewing the application details MTII's Application Engineers proposed the Microtrak 7000 laser displacement sensor (see figure 2) because of the 100 kHz sampling frequency and sub-micron resolution. The customer selected the 7000 because the visible laser spot provides a means for easy setup and alignment of the sensor and the 6" operating distance allowed the laser head to operate outside the sound chamber.
