## Measuring Machining Imperfections and Runout in Automobile Wheel Spindles

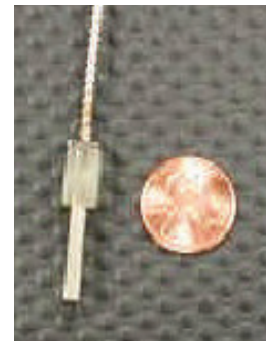
MTII worked closely with the manufacturer and arrived at a unique capacitance sensor design to fulfill the project requirements. The probe design incorporated a rectangular sensing element with an area of 0.020” x 0.10” (0.5 mm x 2.5 mm) and a measurement range of 0.25-mm. Several different tip designs were provided utilizing either a radiussed or chamfered face in order to accommodate a number of different wheel spindle configurations. The probes were used in conjunction with the Accumeasure 9000, an ultra high-resolution capacitance amplifier. Built in digital displays quickly alerted the operator in real time of the test results. connector provides “real-time” output waveform data. This waveform can be analyzed to determine frequency, amplitude and consistency of the horn output, which is helpful in analyzing new horn designs as well as detecting horn defects.
